# 10 WORST PRACTICES BY LIGHT METAL DIE CASTERS

and their impact on productivity

Paul Robbins, General Manager

CASTOOL

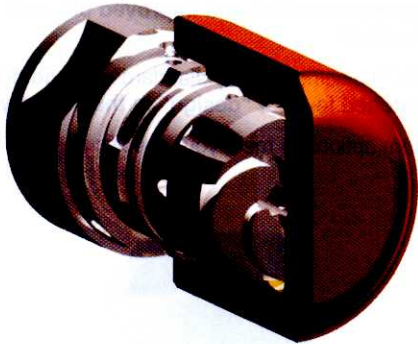
*Dimensionally stable plunger with effective cooling system.*

Most plunger tips are cooled with water. Especially in larger machines, if the plunger tip is not adequately cooled, the crucial gap between the plunger tip and the shot sleeve can disappear. This problem can often be resolved by simply increasing the flow of water. A good flow of coolant through the shot rod is essential. The rate of flow of cooling water is easily measured, and should be monitored frequently. Rate of flow is more critical than the temperature of the cooling water.

Unless both plunger tip and shot sleeve are thermally, and therefore dimensionally stabilized throughout the stroke, the critical gap between them can no longer be maintained.
